Improving Indoor Air Quality in Dental Offices

How minimizing airborne bioburden can reduce the risk of infection.

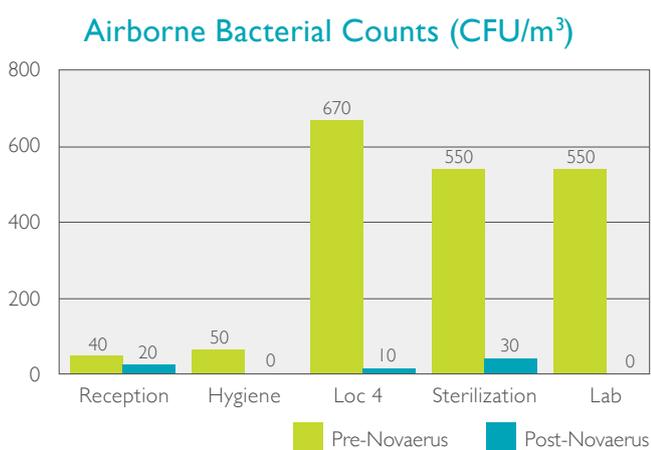
Figure 1: Reduction in airborne bacterial counts following use of Novaerus

Figure 1. shows the reduction in airborne bacterial counts before and after the deployment of the Novaerus NV800/NV900 units. The most prevalent bacteria found in the pre-selected environments were *Bacillus sp.*, *Micrococcus sp.*, and *Staphylococcus sp.* In addition, the Sterilization area showed a prevalence of *Actinomyces sp.*, while the Laboratory area showed a prevalence of *Corynebacterium sp.*

Overall bacterial Colony Forming Units (CFU/ m³) in each of the sampled areas were reduced by more than 95% as a result of the deployment of the Novaerus dis-infection unit.

The efficacy of Novaerus dis-infection technology was evaluated in the dental practice of Dr. Gary Walton, DDS, located in Indianapolis, IN. Air and surface samples of bacterial and fungal counts were taken from five different locations in the dental practice including patient, sterilization, laboratory, hygiene, and reception areas. One Novaerus NV800/NV900 unit was deployed in each of these pre-selected areas across the dental practice. Sampling was conducted from each of these areas before the units were deployed and three weeks (21 days) after deployment in order to evaluate their impact on airborne and surface bacterial and fungal counts.

Airborne bacterial sampling was conducted using

a standard Anderson-type air sampler (air IDEAL[®] 3P Air Sampler; bioMérieux, Inc.). Bacterial culture plates from the air sampling were submitted to EMSL Analytical, Inc. in Indianapolis, IN for the identification and enumeration of culturable bacteria using EMSL Method M009.

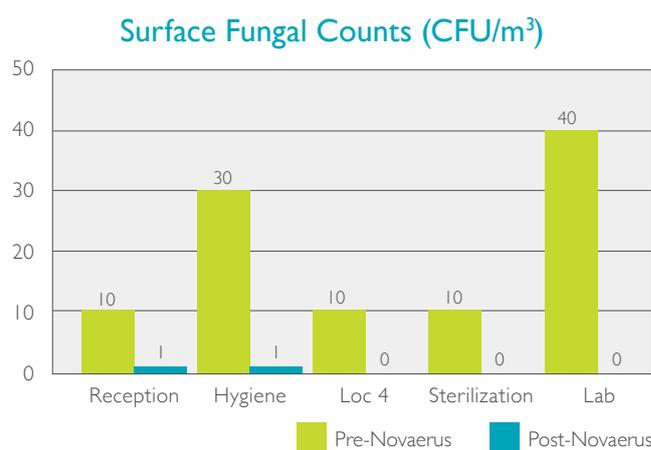
Figure 2: Reduction in surface fungal counts following use of Novaerus

Figure 2. shows the reduction in surface fungal counts before and after the deployment of the Novaerus NV800/NV900 units. The most prevalent fungal specimens found in the pre-selected environments were *Aspergillus sp.*, and *Cladosporium sp.*

During this evaluation, by continually cleaning the air at the point of care, Novaerus technology not only reduced the amount of bioburden in the air but showed a reduction in surface contamination as well.
